# **THE PENNSYLVANIA STATE UNIVERSITY: INTRAMURAL BUILDING PHASE III**

## **TECHNICAL REPORT NUMBER 2**

Name: Issac Colson

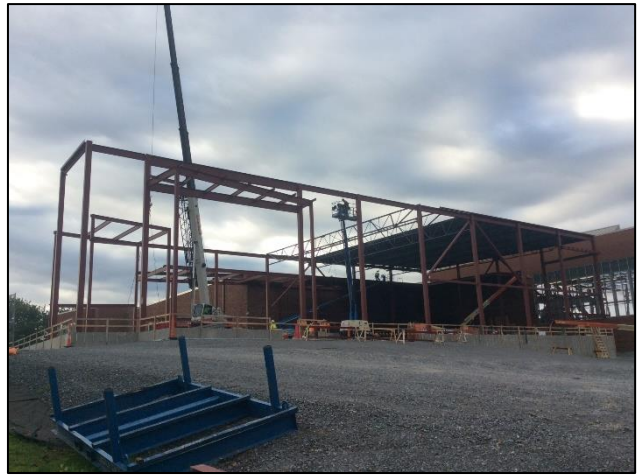
Figure 1: Steel Erection

All steel is designed off site and delivered to the site when the desired pieces are ready to be constructed. The columns are connected to this spread footings using anchor bolts that are imbedded into the concrete forms prior to installation. Next the columns are connect using beams. Steel beams come in a variety of shapes and sizes and for this structure they range from hollow square shapes to wide flanges. Finally, all other steel is installed which includes girders, floor joists and steel decking. These remaining pieces are used to support the slabs and roof which will be poured and installed after erection is complete. All members are lifted by the use of a crawler crane and constructed by a finishing and erection crew.

The steel was erected using a crawler crane, several two man lifts and several industrial forklifts. A tower crane is not feasible for this project and the crawler crane is able to freely move through the site allowing it to be very efficient. Scaffolding was also not used for this project for the structural system. Two man lifts were utilized which allowed workers to move themselves into position and install the members as the crane was ready. Steel erection consisted of a crane operator, a raising gang, finishing gang, and a ground crew. The ground crew monitored the men in the lifts, as well as prepared pieces for the crane to be lifted. The raising gang would “loosely” install the members allowing the finishing gang to come in and permanently fasten each member. The finishing gang follows the raising gang in sequence, and allows for the process to be overlapped, meaning more efficiency for the system, overall.

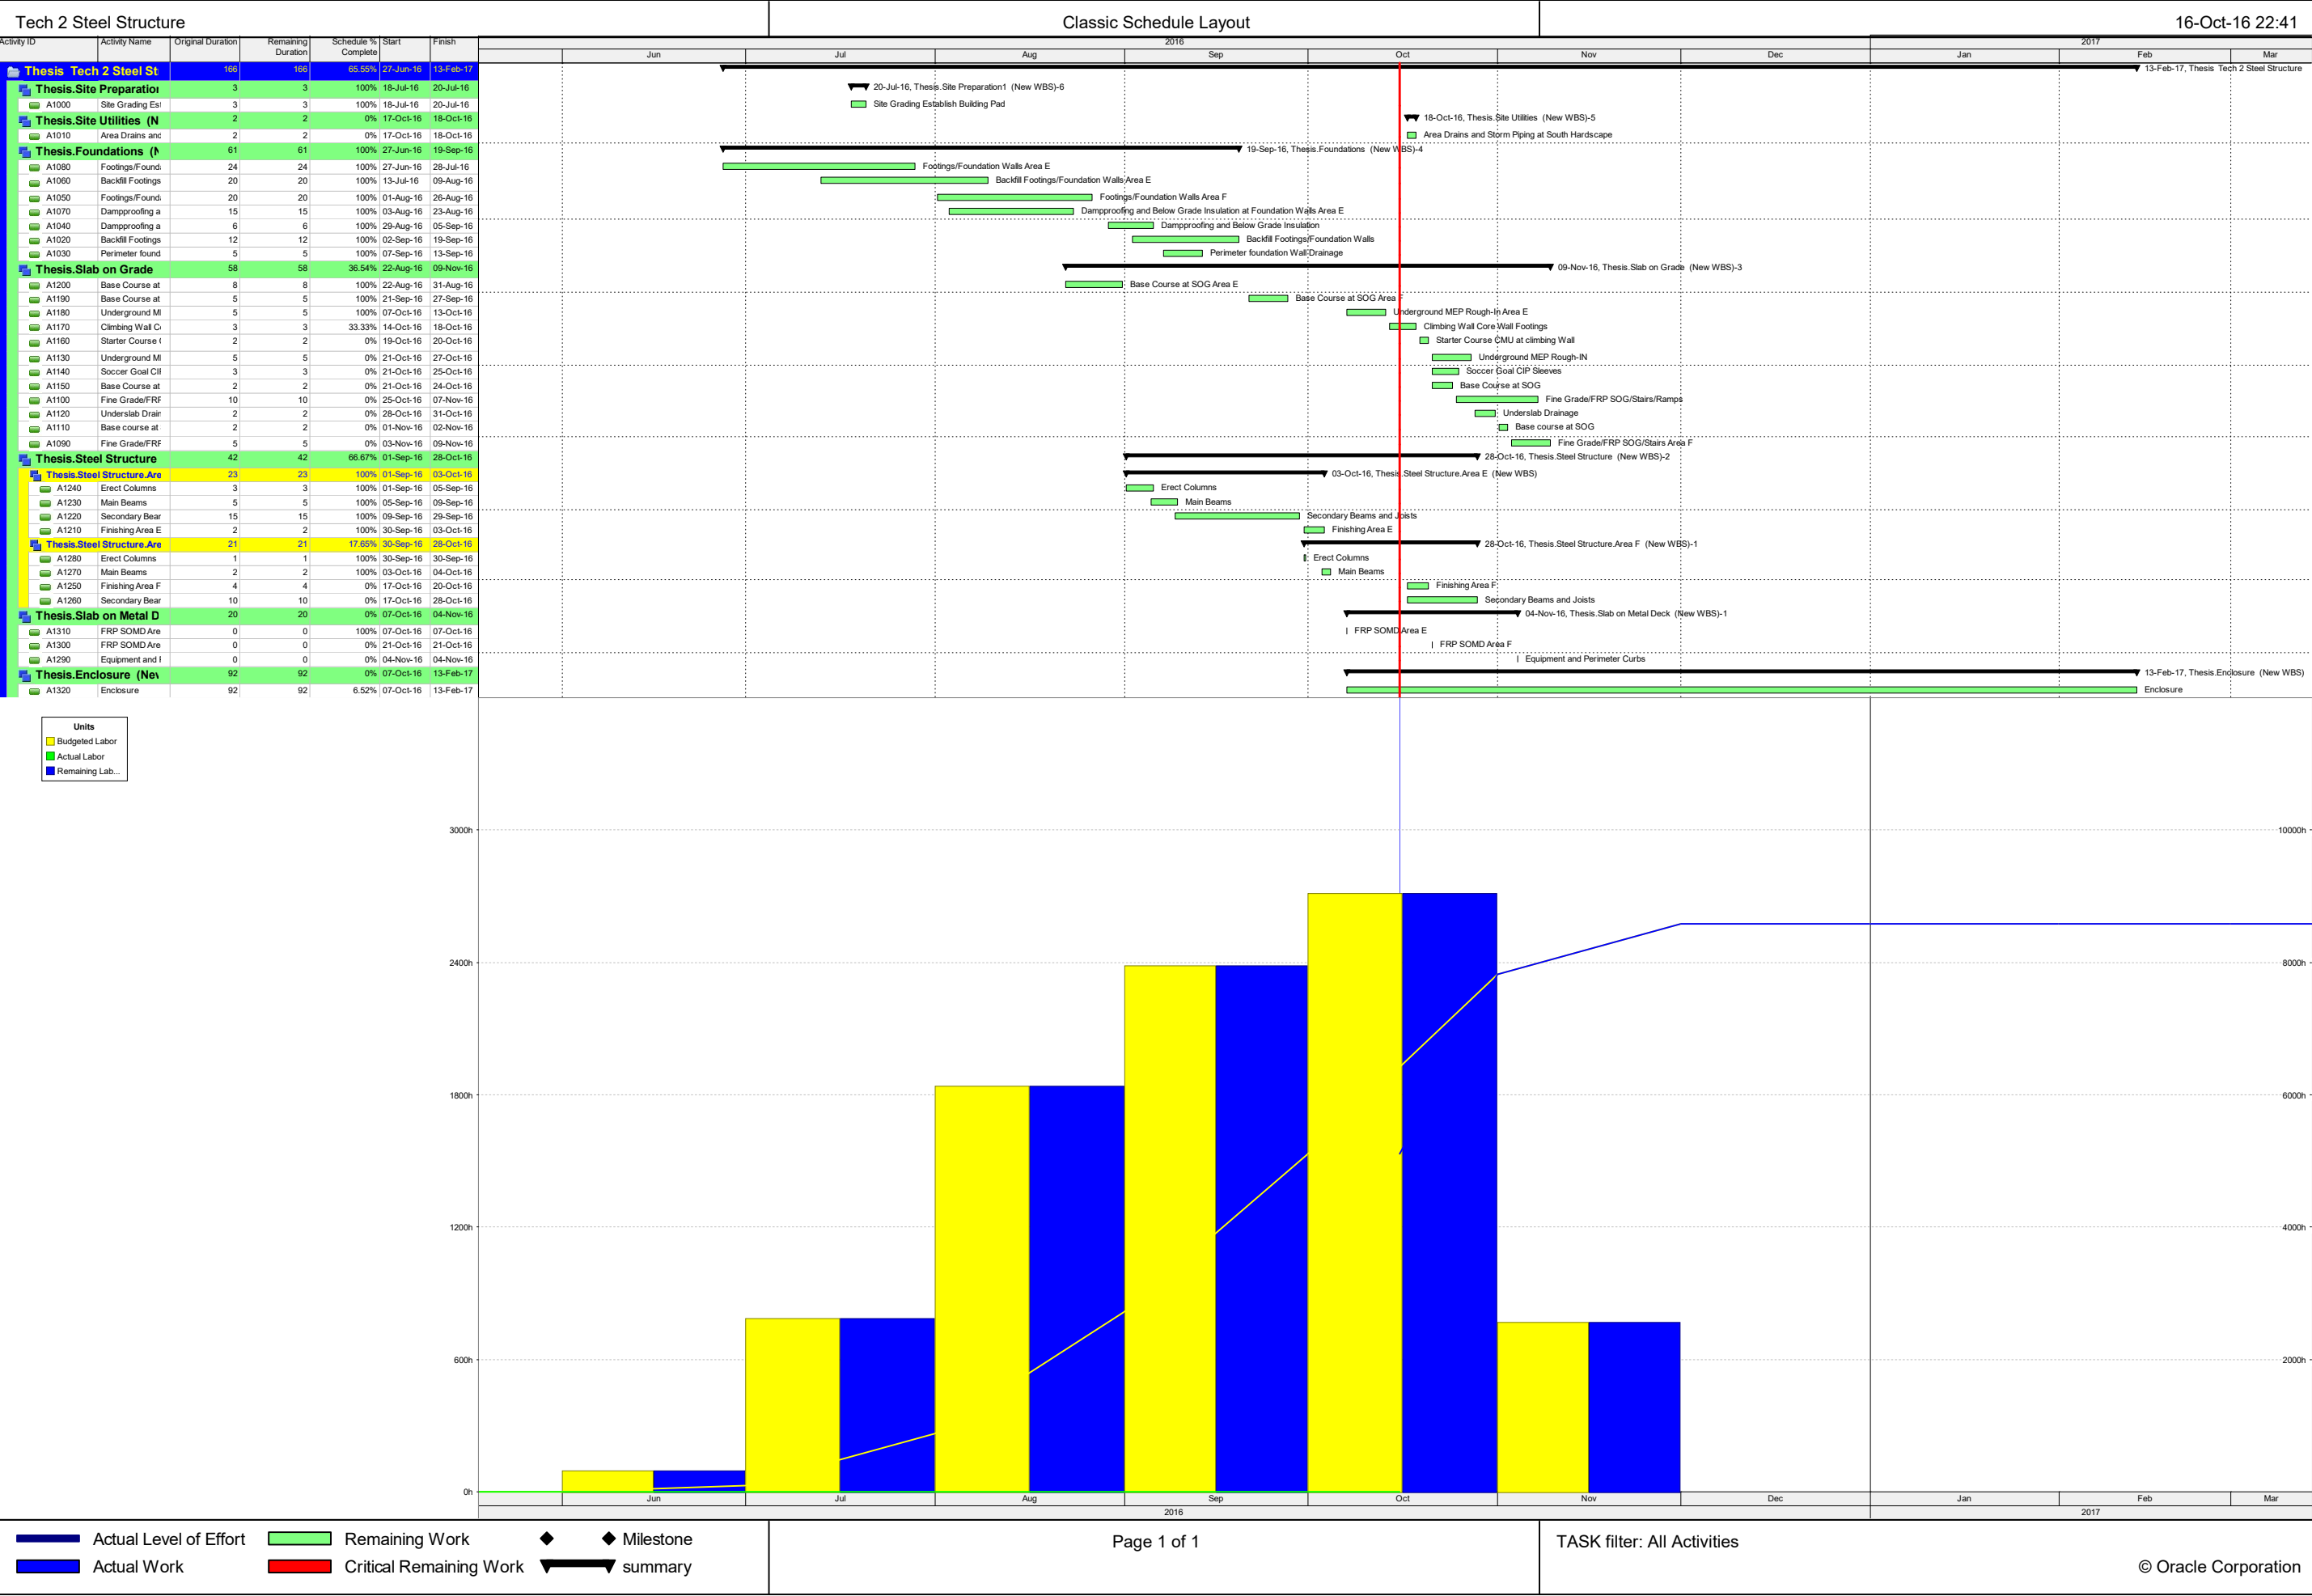
## APPENDIX B: SYSTEM SUMMARY SCHEDULE

The overall duration for the steel erection is 38 days, while the activities necessary to start steel erection have a much longer duration at just under 150 days. The activities needed for steel erection to be completed include all foundation work, slab on grade pouring and forming, as well as underground work for mechanical and electrical systems. Each major activity is broken down by task and scheduled using Primavera scheduling software. The detailed breakdown of these activities and their durations are found in the appendix section of this report. Please visit appendix B for the production schedule.

All activities included in the production schedule are on the critical path of the project. The deadlines for these activities are very important to the overall success of the project. Excavation and the pouring of slabs and footings are events directly prior to the structural steel. These activities are also on the critical path, meaning any delays must be accounted for. The overall duration for the system is 130 days. This is the time of footings starting for area E to the finish of steel in area F.

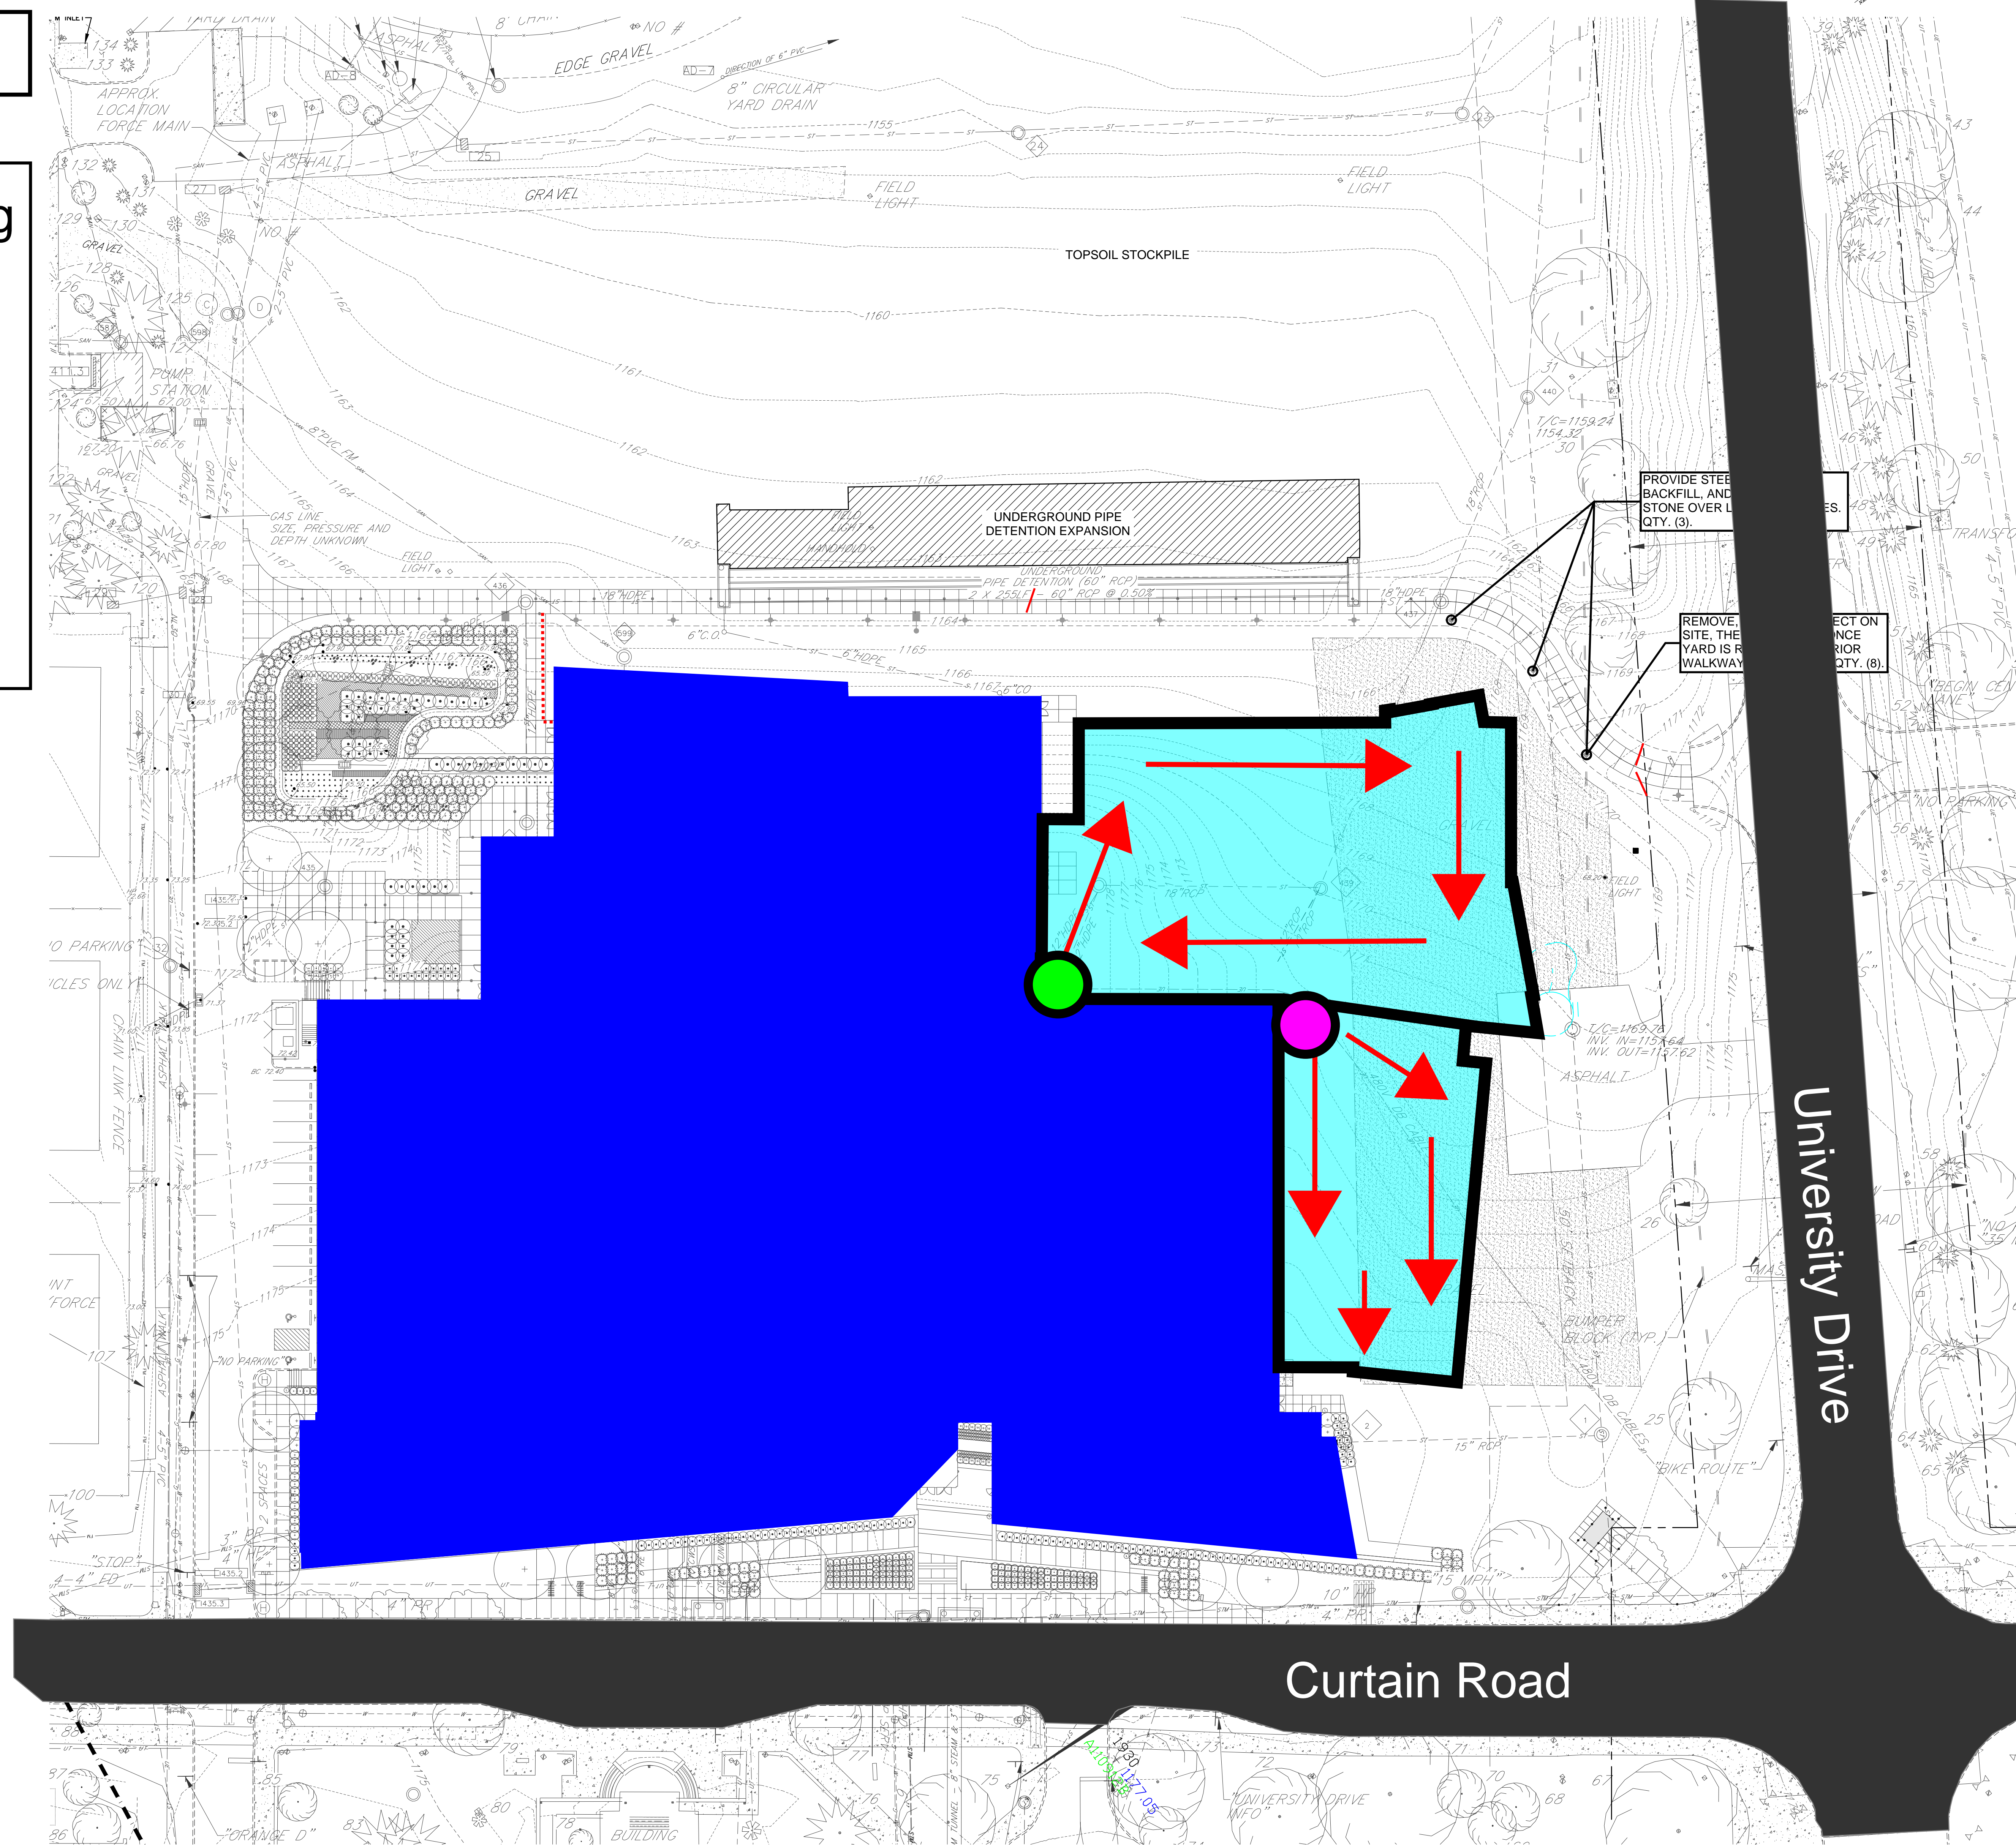
## APPENDIX D: WORKFLOW AND SEQUENCING PLANS

- Existing Building
- Phase III
- Start (E)
- Start (F)
- WorkFlow

The sequencing of the steel began on the interior of the northwest building. The steel was first completed in area E of the addition. The work flow moved in a clockwise rotation. For a better understanding of this work flow, a detailed diagram is located in appendix D.
